**NATIONAL REGISTER OF HISTORIC
PLACES EVALUATION FOR
THE SIERRA PINES BAPTIST CAMP,
ELDORADO NATIONAL FOREST,
EL DORADO COUNTY, CALIFORNIA**

September 2010

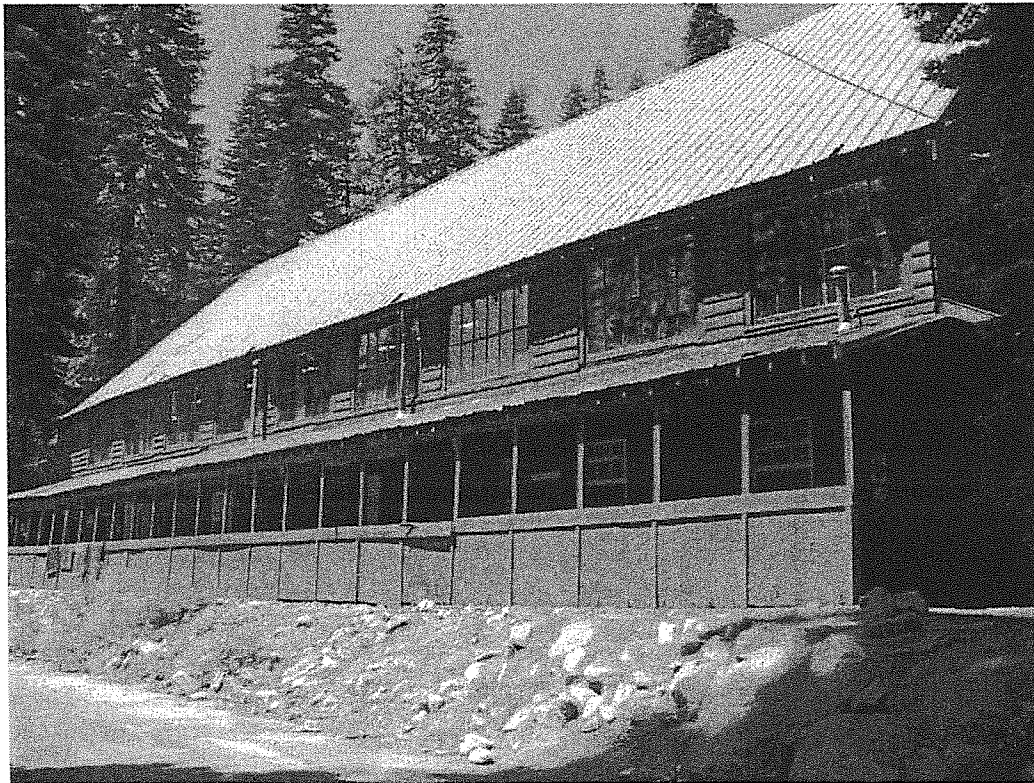
Figure 4. Lodge, dormitory elevation, August 2010.

The lodge (Bldg 1) is a two-story cross-gabled structure (Figures 4 and 5) that houses the kitchen with an addition that is used as office space. The two-story section is 43 feet wide and 100 feet long. The kitchen wing (Figure 5c) is 40 feet long and 41 feet wide. The office addition is 20 by 20 feet.

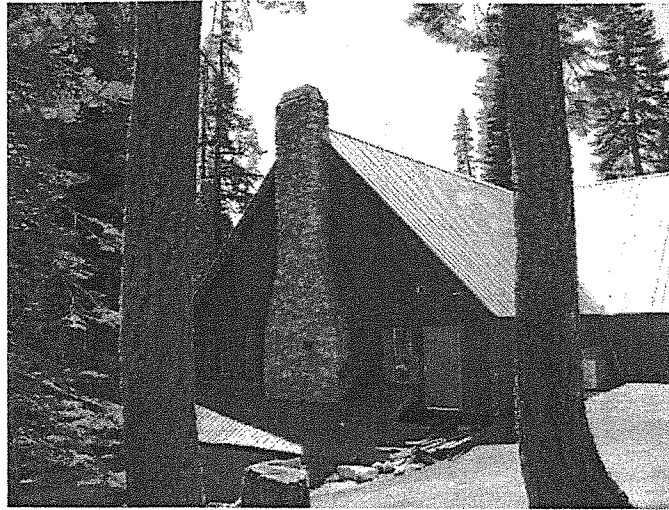
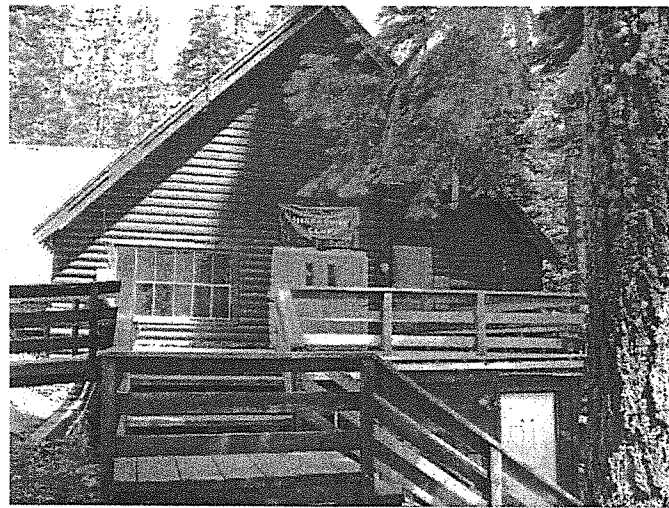
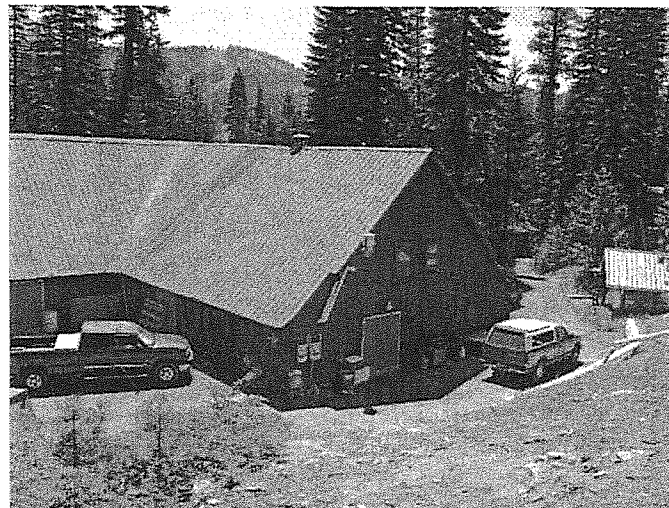
**Figure 5. A: Lodge rear, west and north elevations, August 2010.
 B: Lodge, Office Addition, August 2010.
 C. Lodge, Kitchen Wing, August 2010.**

The lodge office addition (Figure 5b) may have been built before 1960 (50 years ago) and would be considered historic. However, numerous modifications have also been made in the modern period, including replacement of more than 75 percent of the fenestration and 100 percent of the roofing. The roof is channel lock metal. The fenestration on the ground level was replaced with modern vinyl windows. Modern metal replacement doors exist on the kitchen and dining room. There is a modern wood storage addition on the north elevation around the base of the chimney that is constructed of plywood and sheet metal. The dining hall roof collapsed under snow in the last 10 years, requiring replacement of the roof and truss materials and design. The kitchen was also damaged by a falling tree in the last two years, resulting in the removal of original siding and repair with plywood.

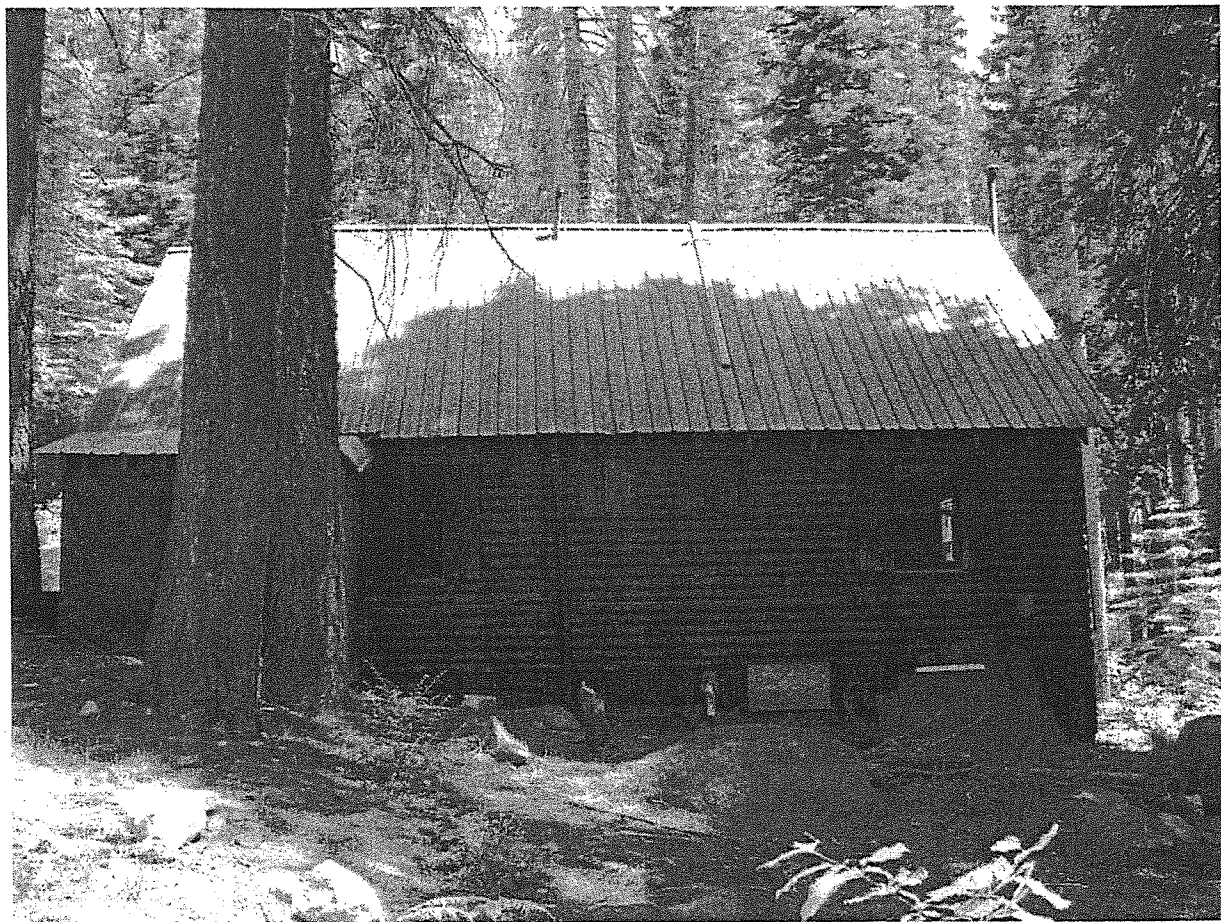
Figure 6: Staff House, Building 2, August 2010.

The two-bedroom staff house (Bldg. 2) is a wood-framed, one-story side-gabled with loft structure (Figure 6) that measures 35 feet long and 20 feet wide. The roof has exposed rafter tails and is clad with channel-lock metal sheeting. The exterior is finished with faux log drop siding. Some (roughly 75 percent) of the original wood-sash double-hung windows remain on this structure. This building was originally the infirmary and was remodeled in 1980 for use as staff housing. The addition is present at left and is sided with horizontal board siding. The roof addition includes exposed rafter tails and a variant of metal roofing material.

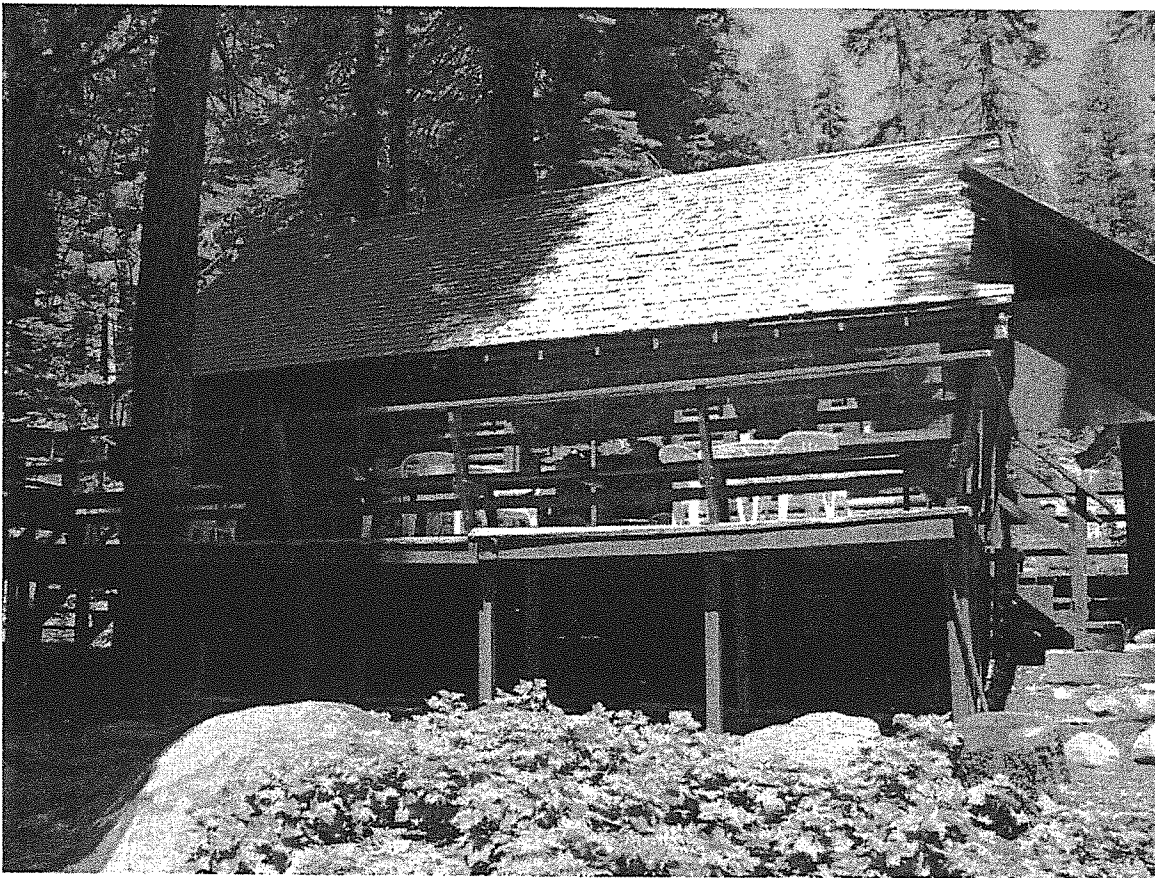
Figure 7: Commissary/Trading Post, Building 7, August 2010.

This one-story, wood-framed front-gabled structure (Bldg. 7) (Figure 7) measures 32 feet long and 16 feet wide. It is set on a concrete pier and sill foundation. The roof has exposed rafter tails and is clad with wood shingles. Access is through an asymmetrically placed modern aluminum sliding door. There are also modern vinyl sliding windows replacing most original windows throughout the structure. The building has been modified significantly with the addition of modern decking and a porch with plywood awning. There are also other replacement materials present, including aluminum casement windows and channel-lock metal roofing.

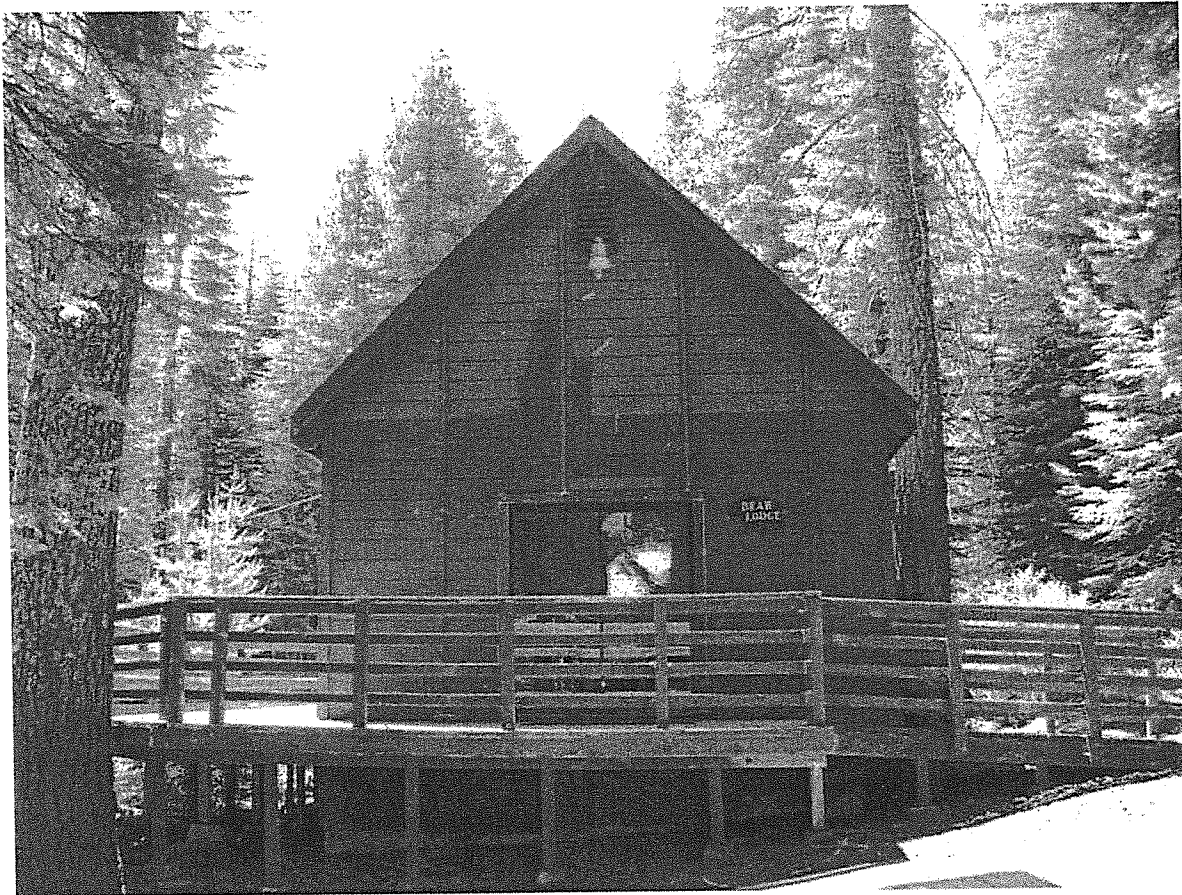
Figure 8. Bear Lodge, Building 8, August 2010.

Bear Lodge is a modern one-story, wood-framed front-gabled building (Figure 8) that measures 32 feet by 18 feet in length. The roof has exposed rafter tails and is clad with channel-lock metal sheeting. Siding consists of horizontal board siding with vertical batten elements. The main entrance on the gable end consists of modern metal sliding doors. A metal louvered vent is present at the attic.

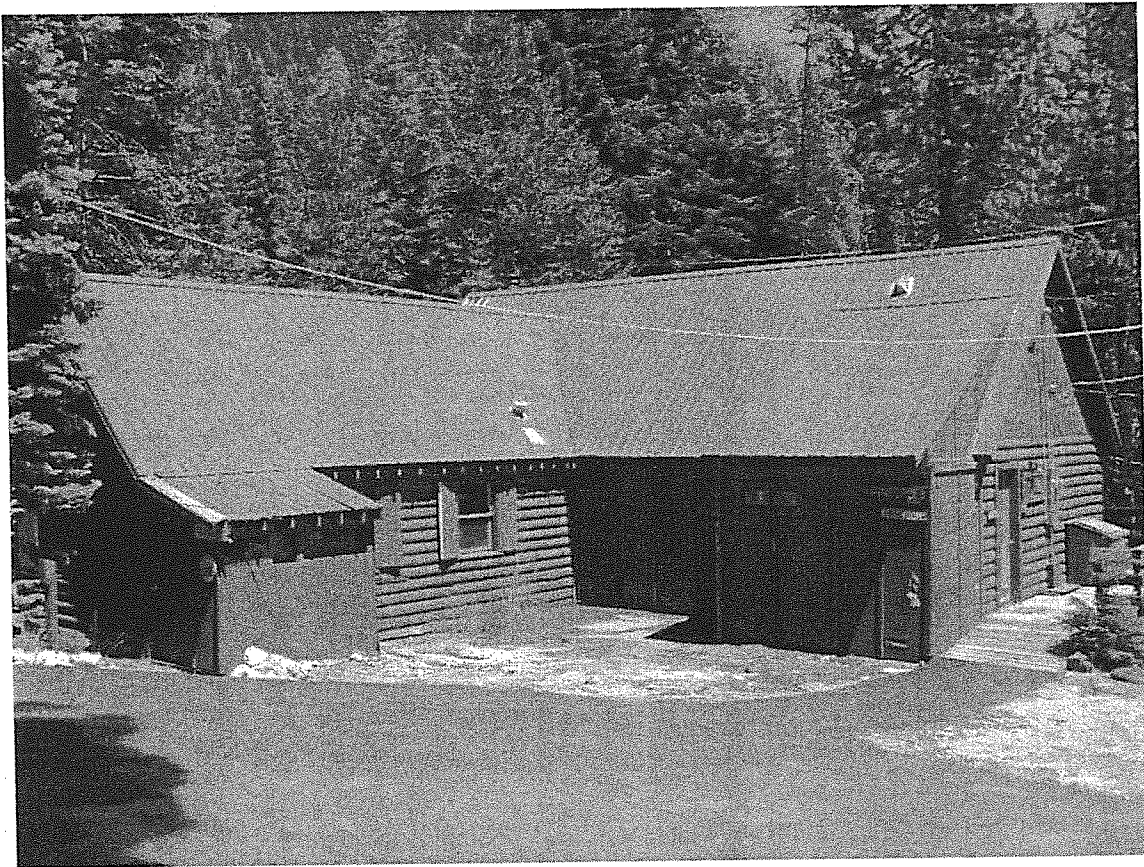
Figure 9. Pinecroft Lodge, August 2010.

This lodge (Figure 9) is a single-story, wood-framed cross-gable-roofed structure that measures 39 feet by 27 feet. The roof has exposed rafter tails and is clad with metal channel-lock sheeting. The modern staff addition on the west elevation is 29 feet long and 17 feet wide and consists of wood framing with plywood siding and a metal shed roof. This building has aluminum sash sliding windows in the main section that have replaced the original fenestration. Exterior conduit for electrical is present as a result of an equipment upgrade. This lodge has two additions. One houses a restroom, while the other is a staff room. The staff addition has plywood siding and a shed roof.

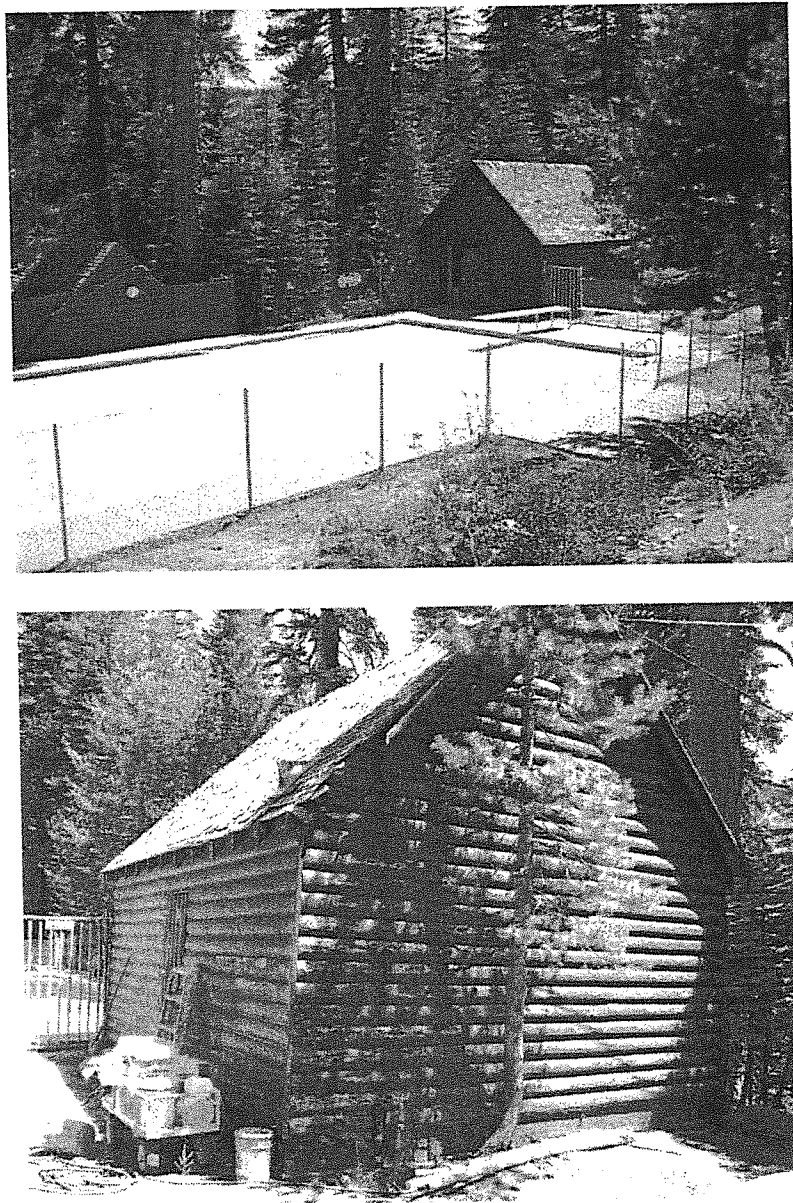
**Figure 10. A: Swimming Pool with Shower House, August 2010.
B: Swimming Pool Shower House, August 2010.**

The showerhouse (Building 10) at the pool (Figure 10) is a simple one-story, wood-framed structure on a concrete sill foundation and measures roughly 18 feet by 10 feet. This building was likely constructed around 1953, contemporary with the swimming pool. The front-gabled structure is clad with faux log drop siding from ridgeline to foundation. The roof has exposed rafter tails and is clad with deteriorated wood shingles. The access is through modern replacement double doors facing the pool enclosure. There is an additional pedestrian door on the west elevation that consists of vertical boards.

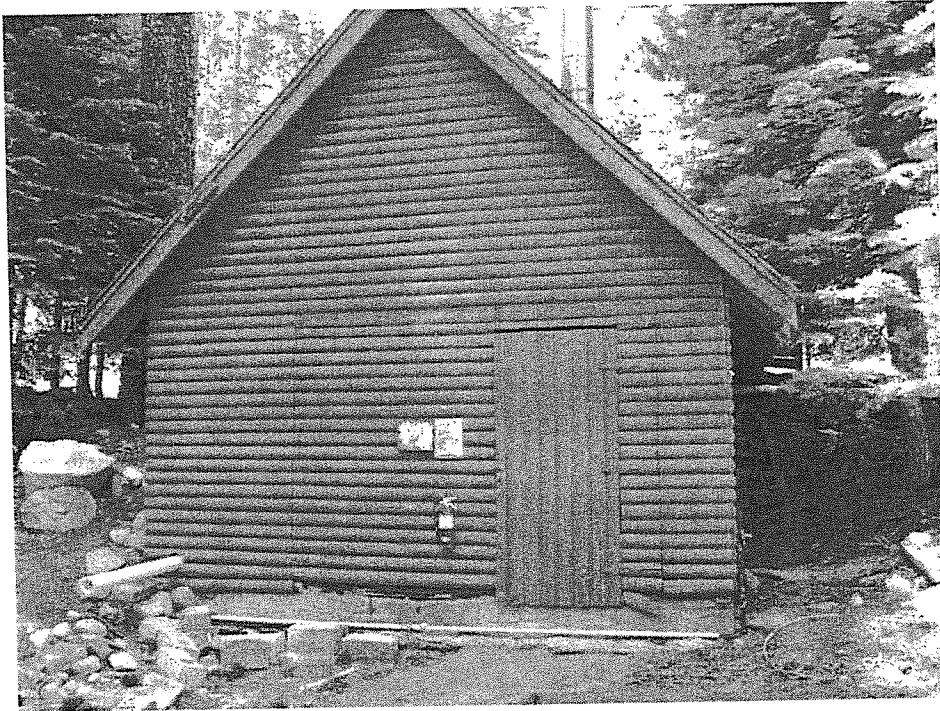
Figure 11: Pool Pump House, August 2010.

Building 11 measures 20 feet wide by 16 feet in length. The pump house (Figure 11) is wood-framed with a modern cinder block expansion on a concrete sill foundation. The one-story building is clad with faux log drop siding from ridgeline to ground level. The rear of the building shows modifications, including the replacement of the original access door with vertically placed siding. Fenestration has been replaced with aluminum sash sliding windows. The roof has exposed rafter tails and is clad with metal channel lock sheeting.

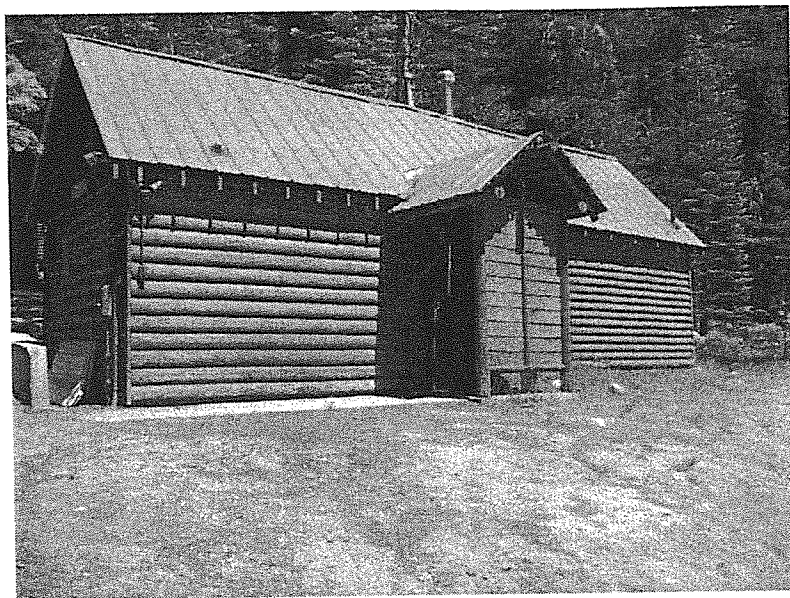
This rectangularly massed, wood-framed side-gabled building (Building 5) (Figure 12a) measures 32 feet long by 12 feet wide. The one-story structure has a centrally placed pedestrian door visually screened by a cross-gable portico supported by poles and is finished with horizontal board siding. The building itself has faux log drop siding on two elevations and replacement plywood siding on the rear. Roofing consists of modern channel lock metal sheeting with exposed rafter tails. Windows consist of replacement aluminum sliding windows for ventilation.

**Figure 12. A: Women's Bathroom, Building 5, August 2010.
B: Abandoned Bathrooms, Building 17, August 2010.**

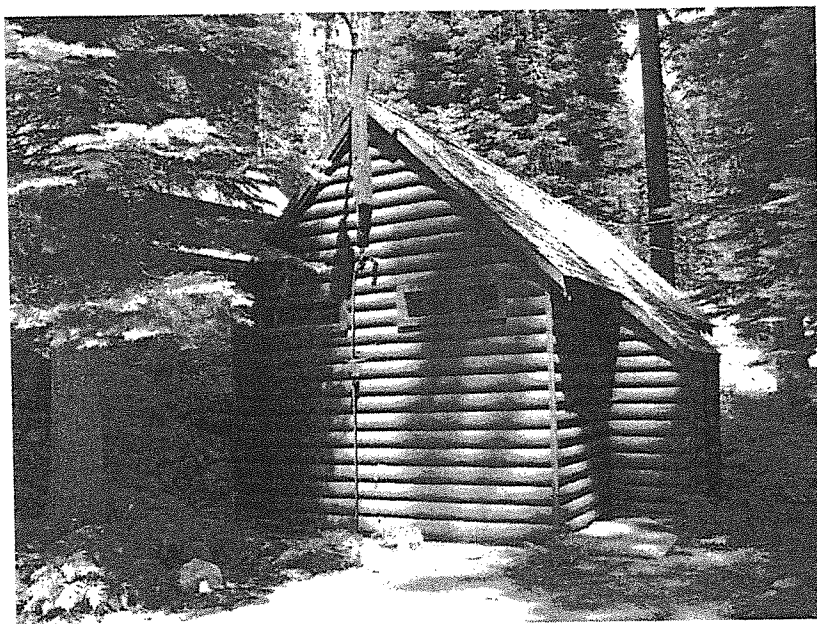
This is an abandoned side-gabled wood-framed structure (Figure 12b) that measures 25 feet by 22 feet. The structure is similar in design to the bathrooms near the cabins also constructed in 1948. Siding consists of faux log drop-siding. There are screened horizontal vents at the eave elevation. The original shingle roof remains in place, although in poor condition.

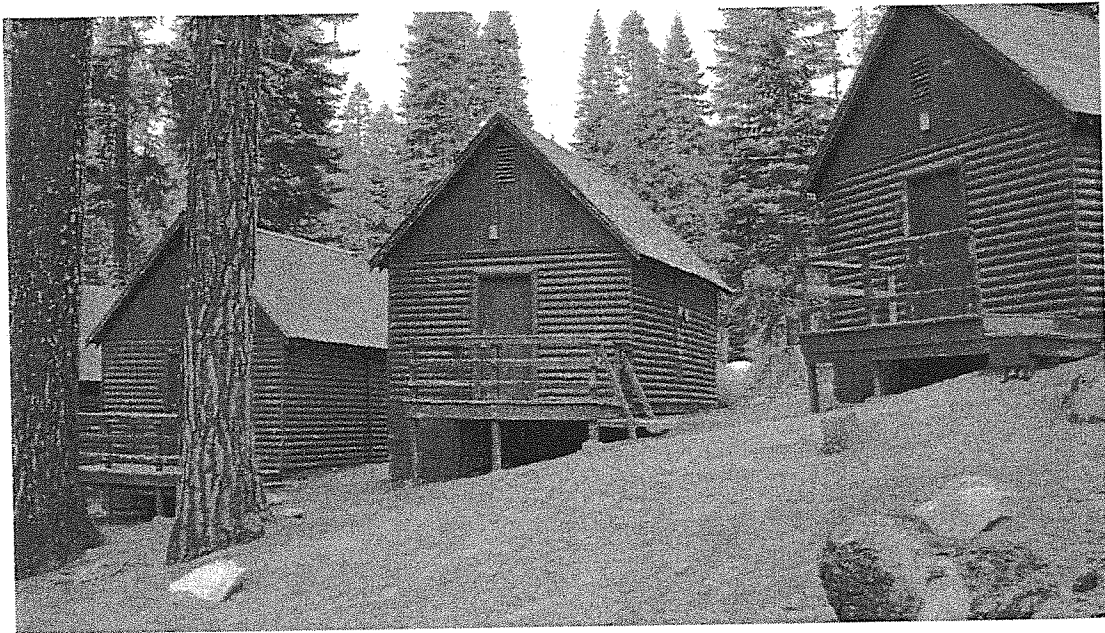
Figure 13: Representative Cabins, Constructed 1948, August 2010.

There are 25 similar cabins (Figure 13) clustered in a horse-shoe shape at the east side of the camp. The cabins each measure about 18 feet by 15 feet. At least three of these cabins have been completely reconstructed. These wood-framed front-gabled structures are simple one-story buildings on concrete pier foundations. They are clad with faux log drop siding from the eave line to the floor elevation. In the gable end and below the floor elevation, they are clad with either horizontal and vertical board siding. There is a louvered metal vent present in the gable of each cabin. Doors all appear to be simple wood panel doors and provide access by simple wooden decks with two-by-four railings. The cabins each have one modern aluminum sliding window at the rear elevation. Roofing is inconsistent and varies from shingle to channel lock metal sheets or a combination of both. All have exposed rafter tails. Cabins have electric lights and heating.
